HP-19C Repair Birthday Workshop, an Odyssey

Bernhard Emese, Jef Ongena, February 2021

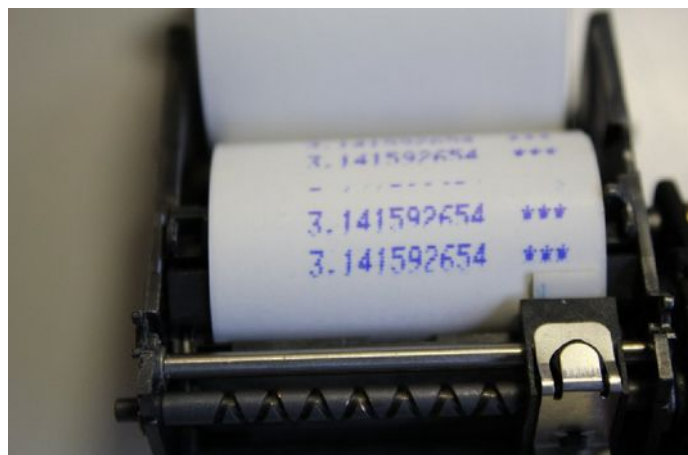
I could now push the printhead into the HP-19C printer module and connect the HP-97 flexcable provisionally to the HP-19C printer board. And when I shifted the printhead more upwards, it printed the complete number, although the lowest line was a little weak.

Probably the first time ever an HP-97 printhead was working in an HP-19C.
